LIGHTNING EFFECTS RELATING TO AIRCRAFT
PART I - LIGHTNING EFFECTS ON AND ELECTROMAGNETIC
SHIELDING PROPERTIES OF BORON AND GRAPHITE
REINFORCED COMPOSITE MATERIALS

F.A. Fisher
High Voltage Laboratory
General Electric Company

Technical Report AFAL-TR-72-5

January 1972

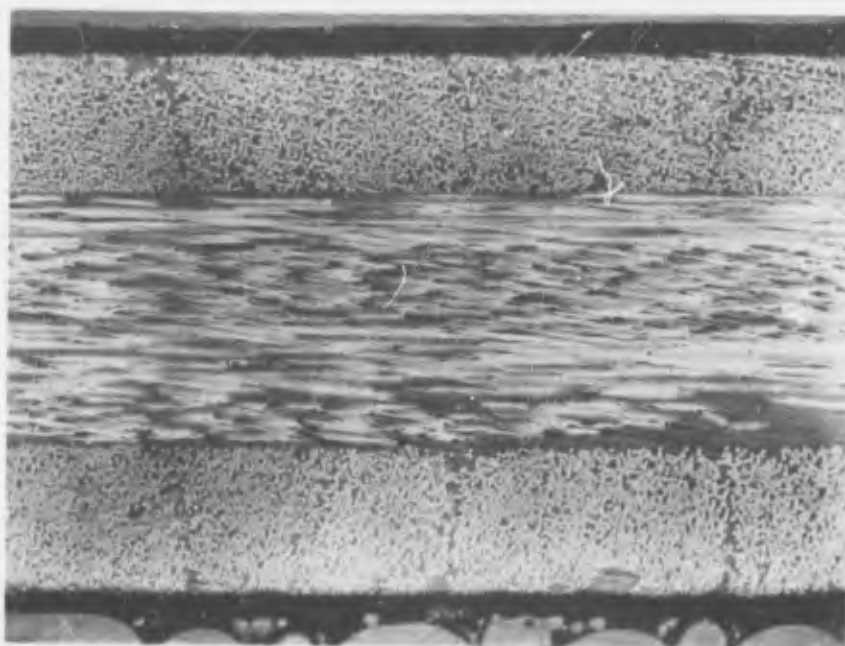
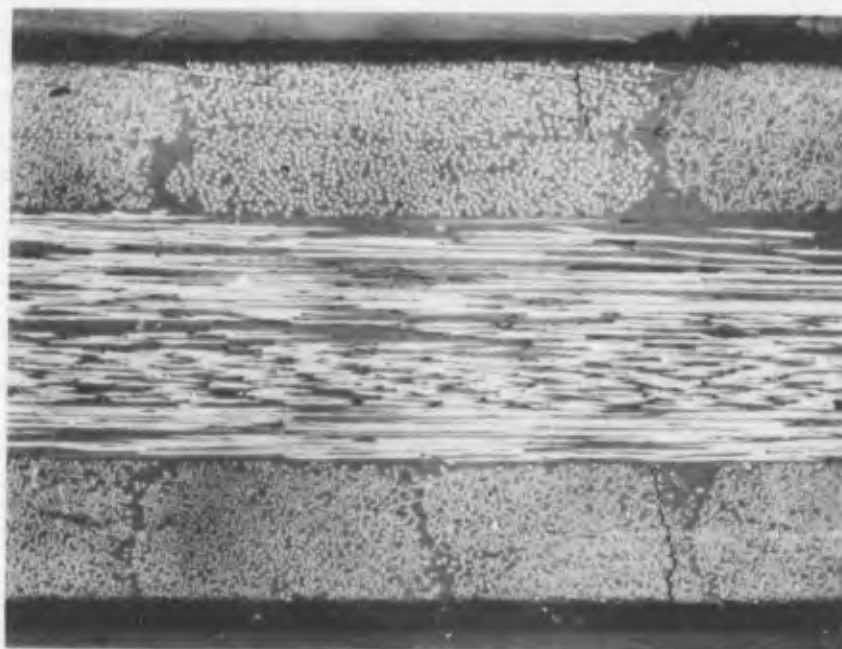
Overall appearances of the chosen areas had no drastic or obvious physical differences in material appearance under plain and polarized reflected light. Sample LS-70-2 and LS-70-4 contained less dense (black) lines. Examination of these lines showed that the dark (lower density) lines of both samples are caused by the presence of bundles of fibers with individual fiber diameters measuring 8 to 10 microns, or twice that of the surrounding matrix graphite. The various photomicrographs are shown on Figures 56 through 58. It can be noted in the photomicrographs of LS-70-2 and LS-70-4 at 200X that packing densities for the bundles of larger diameter fibers are strikingly less than the adjacent bundles made of smaller diameter filaments. One bundle photographed at 100X shows a cross-section diameter of 0.7 millimeter. Measurements of the same line on the X-ray print shows that line to be somewhat less than 1 millimeter (estimated to be 0.75 millimeter using a millimeter scale). Two such areas in

FIGURE 57 - Photomicrographs Showing the Differences Between a Dense Area and the Dark Line of Panel LS-70-2

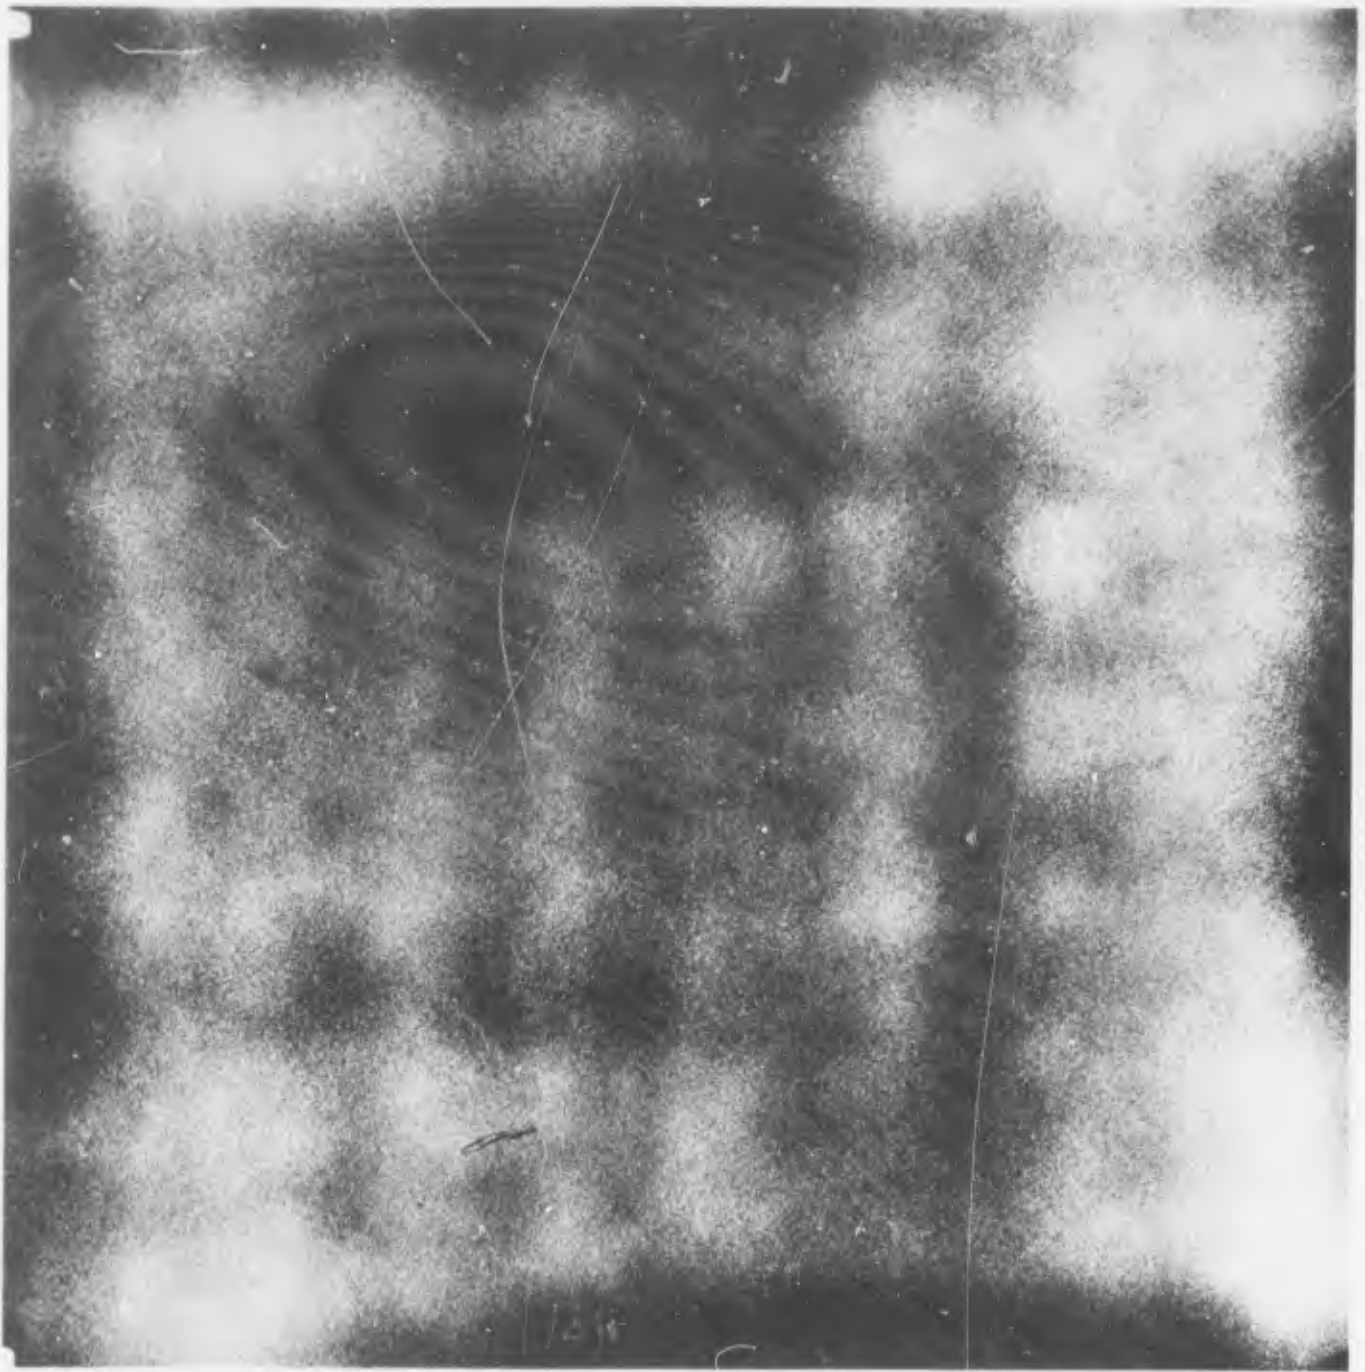
Reference X-ray radiographs were also made of the silver-paint coated panels. The very large difference in atomic numbers between silver and the graphite-epoxy makes it impossible to determine structural details of the graphite either on the original radiograph or on the separation negative. The variation of the paint film was clearly shown on each sample. Figure 59 is a typical print made from a separation negative to enhance the contrast of the original radiograph. The lighter bands represent increased thickness. Apparently the panels were spray-painted with two coats, with the gun travel at 90° on successive coats. The white specks correspond to "pimples" on the painted surface.

FIGURE 59 - Photo Extraction Showing Variations of Silver-Paint Coating Thickness - Typical for Panels LS-70-5 through LS-70-8

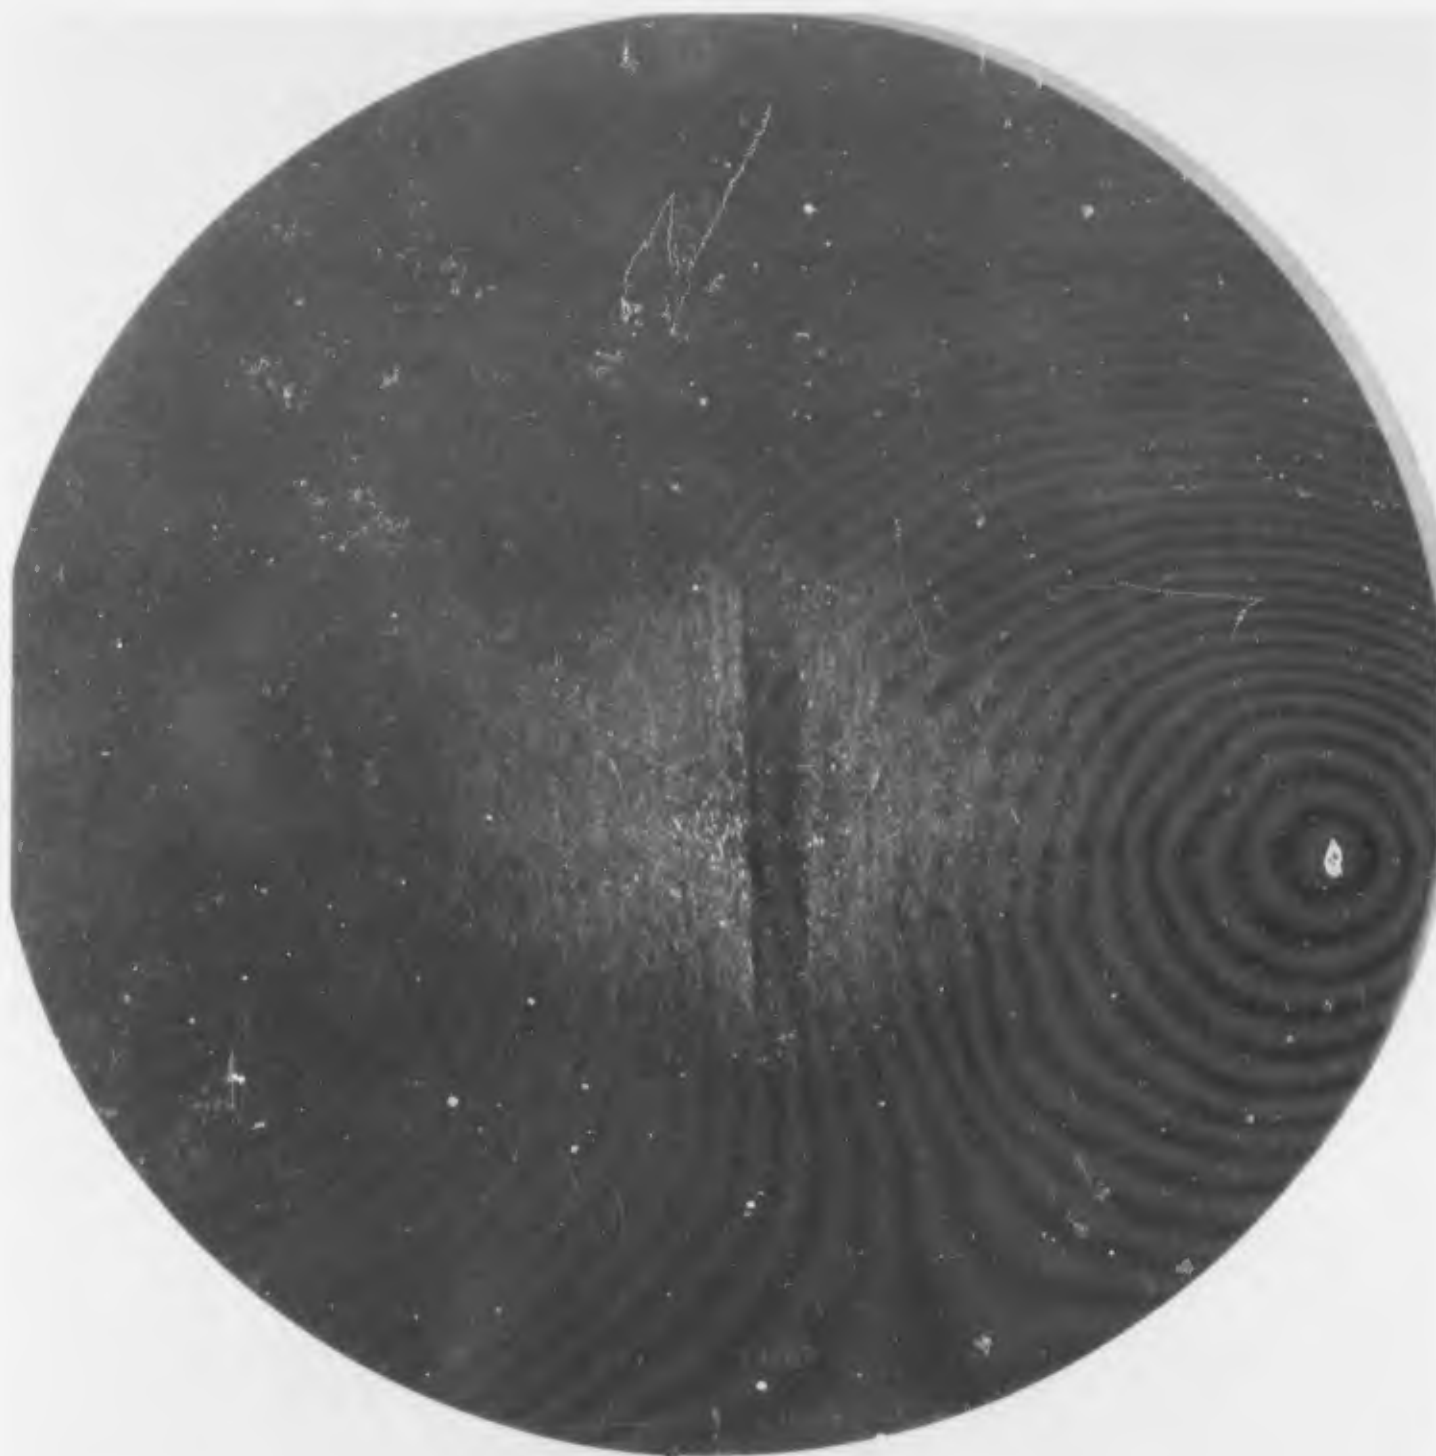
Photographs of the damage caused by the simulated lightning discharge to the four uncoated panels (LS-70-1 through LS-70-4) of 0.040" thickness is shown on Figure 65 through Figure 68 respectively.

LS-70-1 (Front)
(85 kA)

FIGURE 65 - Damage to Uncoated Graphite Fiber/Epoxy Panel by Simulated Lightning Discharge

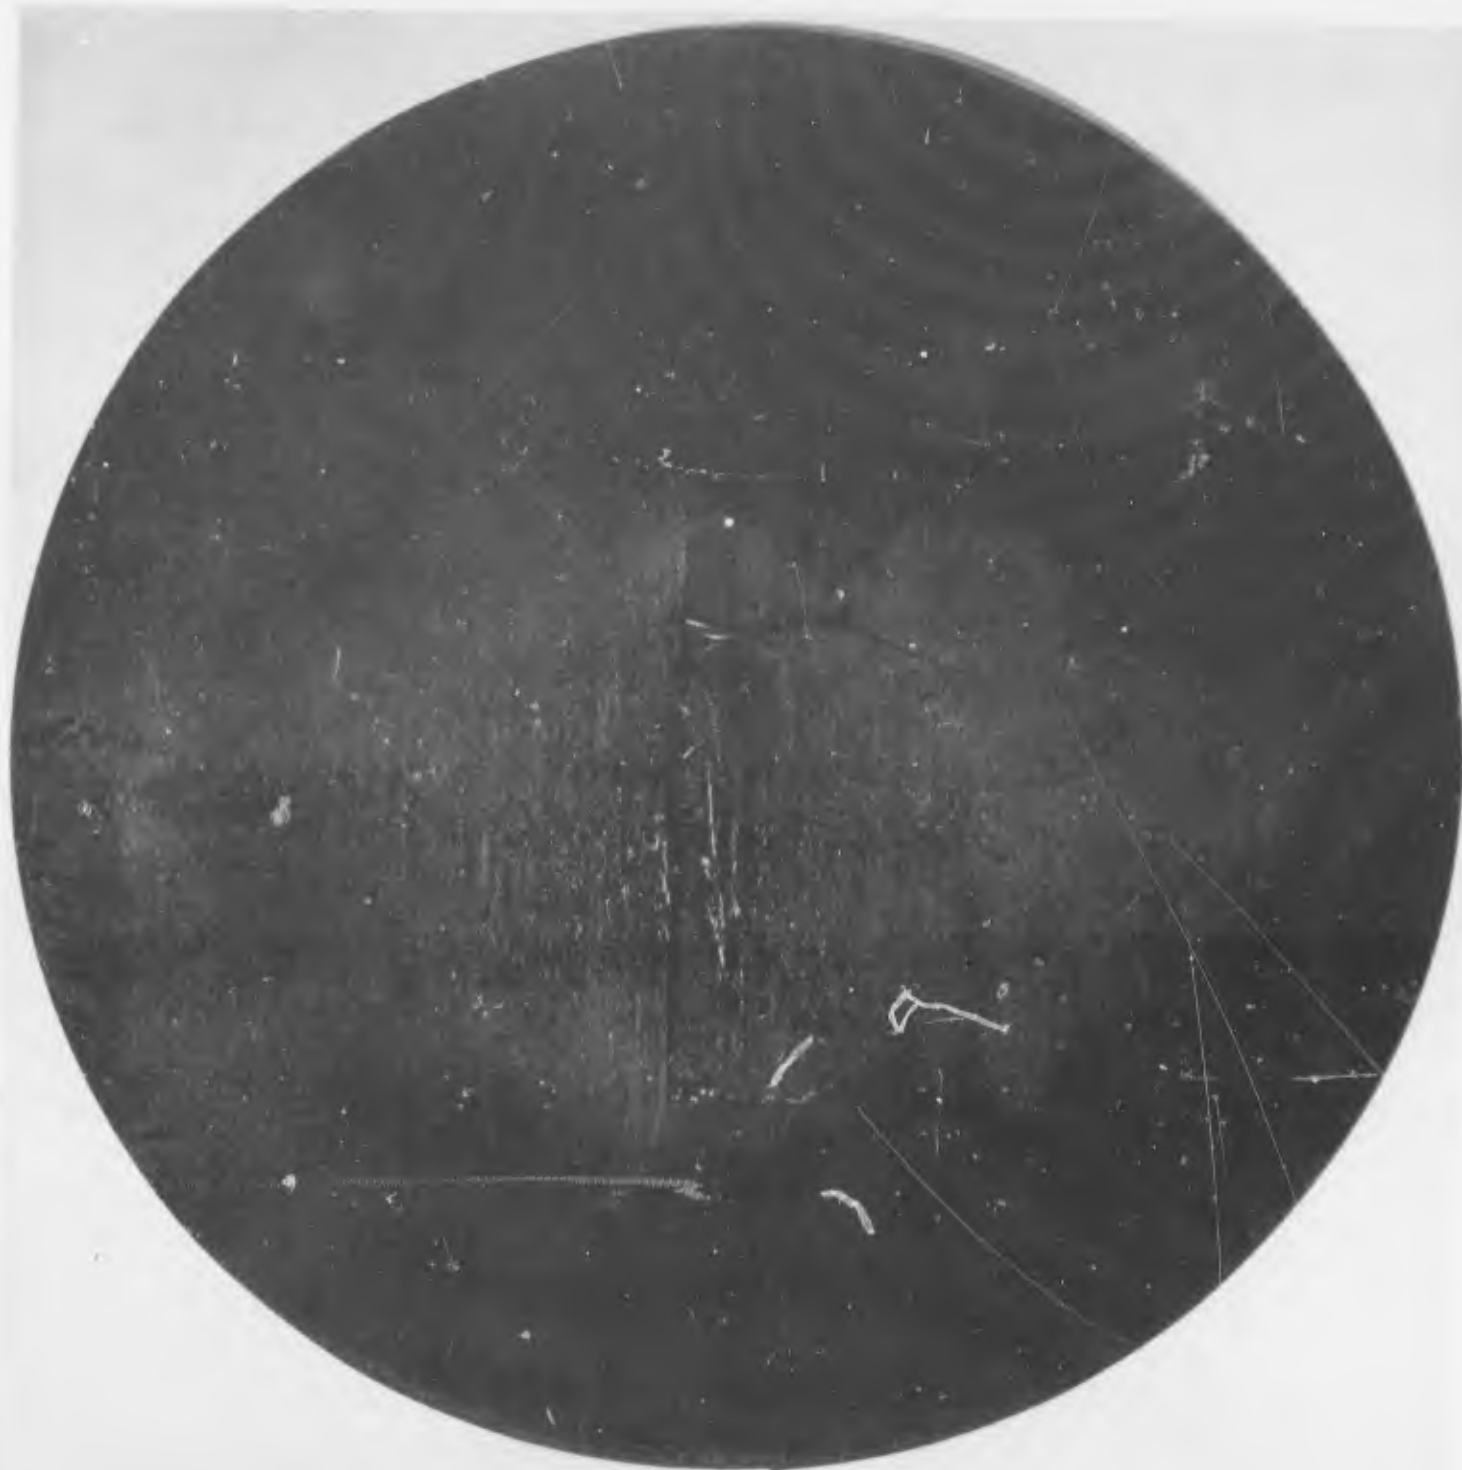
LS-70-4 (Front)
(184 kA)

FIGURE 68 - Damage to Uncoated Graphite Fiber/Epoxy Panel by Simulated Lightning Discharge

This panel sustained the same type of damage as panels LS-70-1 through LS-70-3, but on a more extensive scale. The disruption of the top ply extended approximately the diameter of the panel in a direction perpendicular to the direction of the top ply. A majority of the current flowed in this perpendicular direction, as verified by the disruption of fibers at the points where the panel is clamped to the retaining ring. The front surface damage on this panel flared outward laterally 5" with ply blow-off measuring 5-1/4" x 1/2", shredded badly at the center. The delamination extended nearly 5" along the top ply and about 1" to each side of the stroke-attachment area. Fibers in the delaminated ply were loosened but still in place. It should be noted that the actual damage to this panel appeared less extensive than that sustained by the Panel LS-70-7 which had a silver-paint coating.

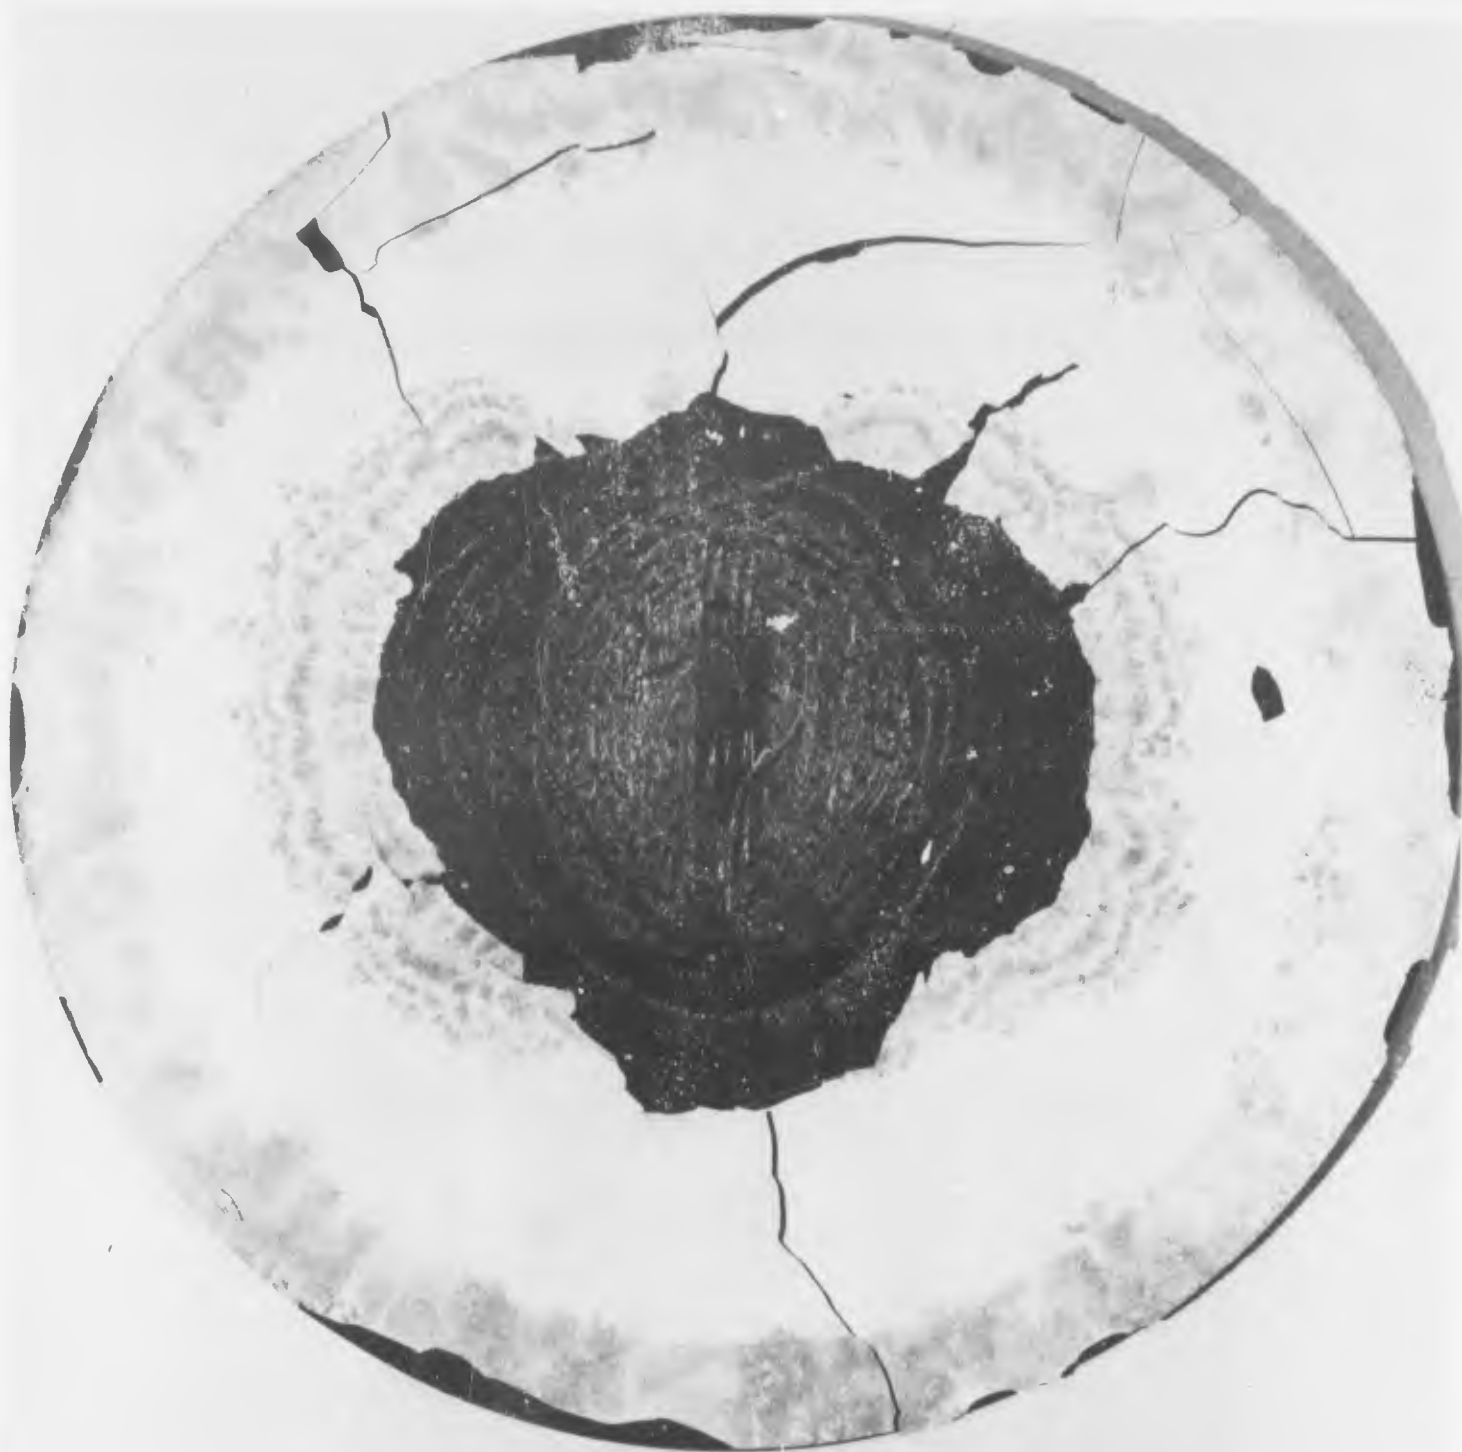
LS-70-8 Silver Paint

FIGURE 74 - Damage to Graphite Fiber/Epoxy Panel Surface Coated with Silver Paint, After Exposure to Simulated Lightning Discharge

These panels are most nearly comparable to the uncoated panel LS-70-1 which was tested at 85 kA. Visually, the front surfaces of panels LS-70-6 (103 kA) and LS-70-8 (104.5 kA) appeared nearly alike. Damage to LS-70-6 measured 4-1/2" in diameter with front ply blow-off 3/16" x 3-1/8". The damage to the front of panel LS-70-8 was 4-1/2" x 4" with a 3/8" x 2-1/2" strip of the ply blown off. In both of these cases the back surfaces were damaged to nearly the same extent in size and shape - 3/8" tapering to 1" on both ends. The back surfaces of each show strain ripples when light is reflected from the surfaces at critical angles. Strained areas were 3-1/2" x 3" on panel LS-70-6 and 3" x 1-1/2" on panel LS-70-8. Again, the area of damage on the sample with silver-paint coating was circular in area, contrasted to the elliptical area on the uncoated panel LS-70-1. The speckled pattern was again noted around the outer periphery of the damaged area. If at these points current flows back out of the graphite material into the silver-paint coating, one would expect the current density around the outer periphery of this panel to be less than on the uncoated panel. This seems to be the case if one compares Figures 68 and 72. On the uncoated panel there were found the typical pyrolyzed points near the ground end at which current was flowing out of the panel into the ground structure. These were much less evident on the silver-paint coated panel.

The pattern of damage seen in Figures 71 and 74 to the silver coating of panels LS-70-6 and LS-70-8 was considerably different, although they were tested at almost the same current level. This occurred as a result of the method of grounding used on panel LS-70-8. This panel was tested with the uncoated side of the composite panel isolated from ground and the current path to ground attached only to the coated side, in contrast to all other panels in which grounded structure was clamped on both sides of the panel. The back side of the panel was isolated electrically

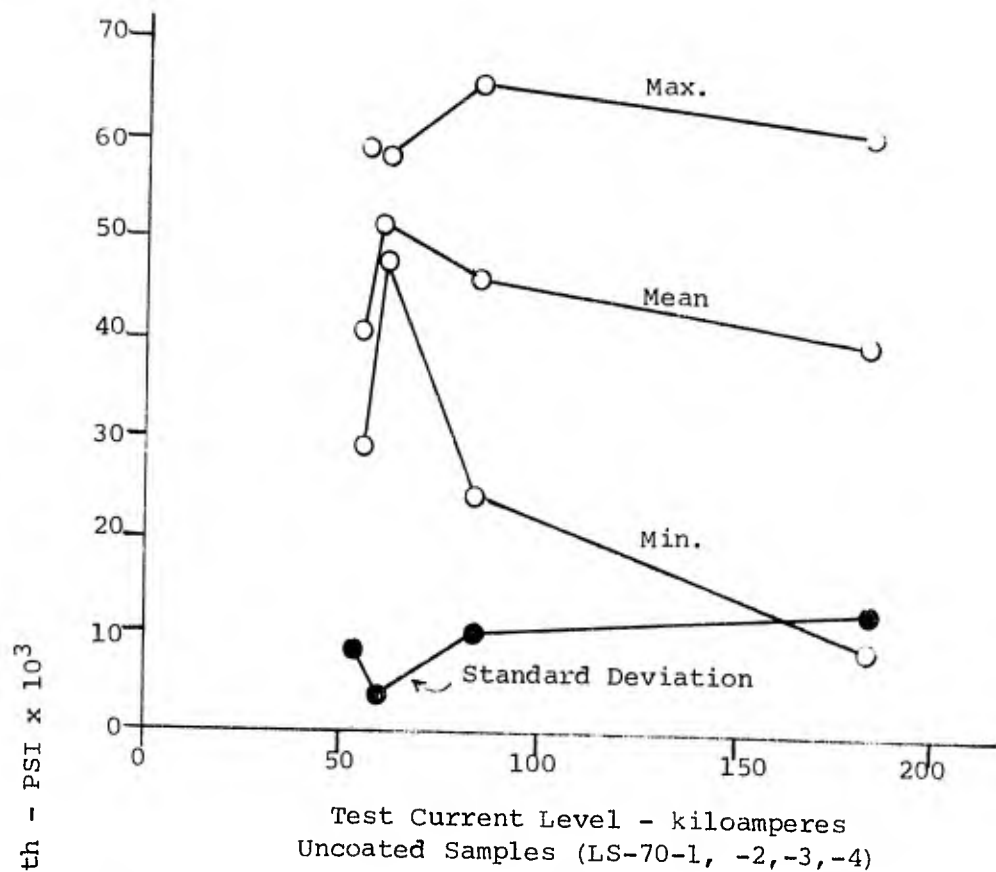
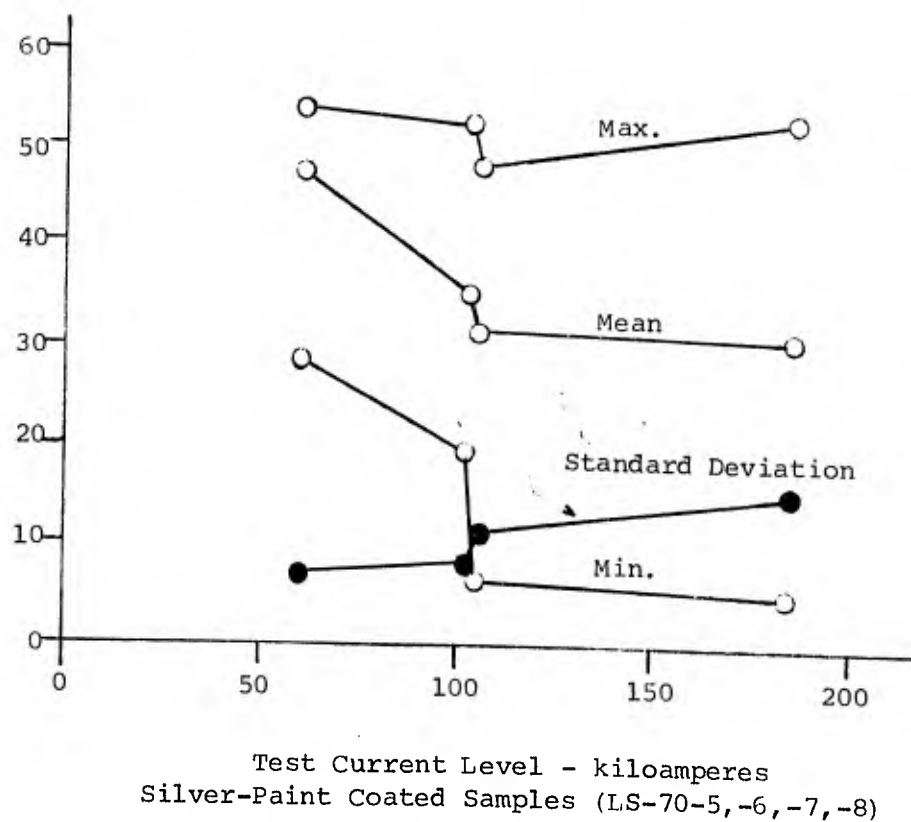
shown on Table XIV and plotted on Figures 76 through 78. On Figure 76 (for either coated or silver painted panels) the tensile strengths of all the specimens, near to and removed from the arc attachment point are grouped. There is a large spread between maximum and minimum tensile strengths since specimens near the arc at attachment point were more severely damaged than those farther away from the arc attachment point.

FIGURE 76 - Tensile Strengths of All Specimens Cut From 0.040" Thick Graphite Fiber/Epoxy Panels

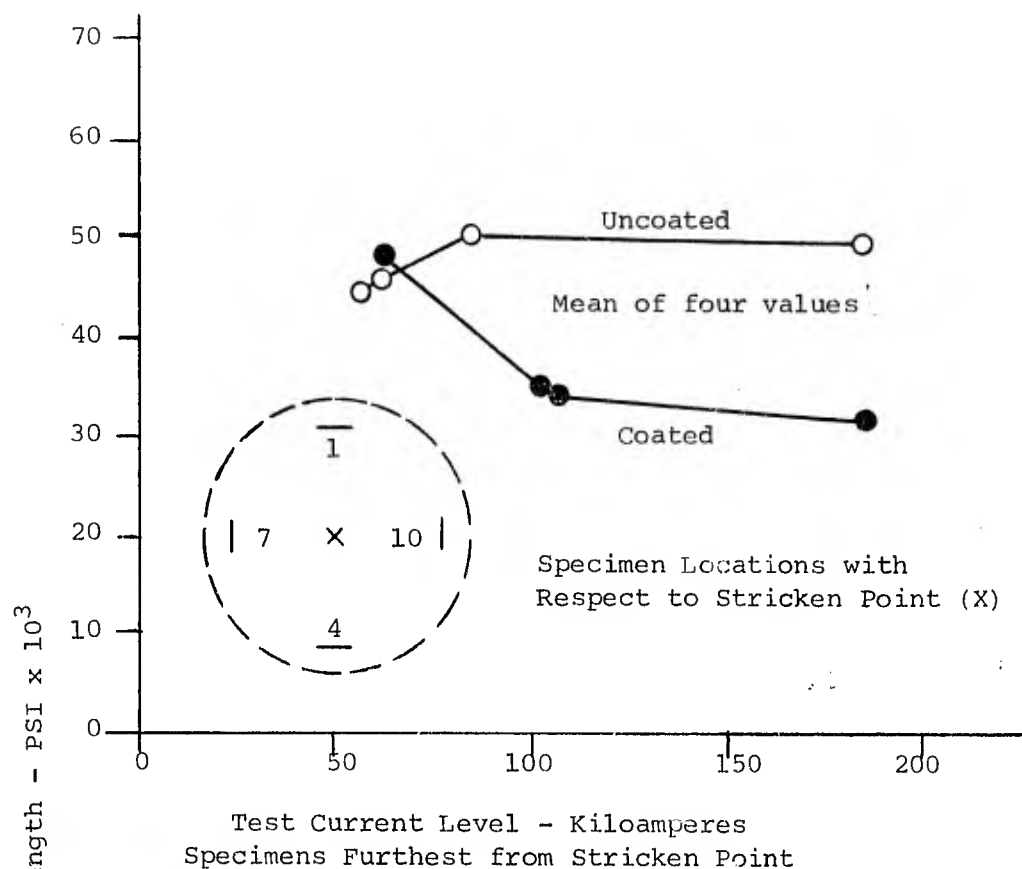
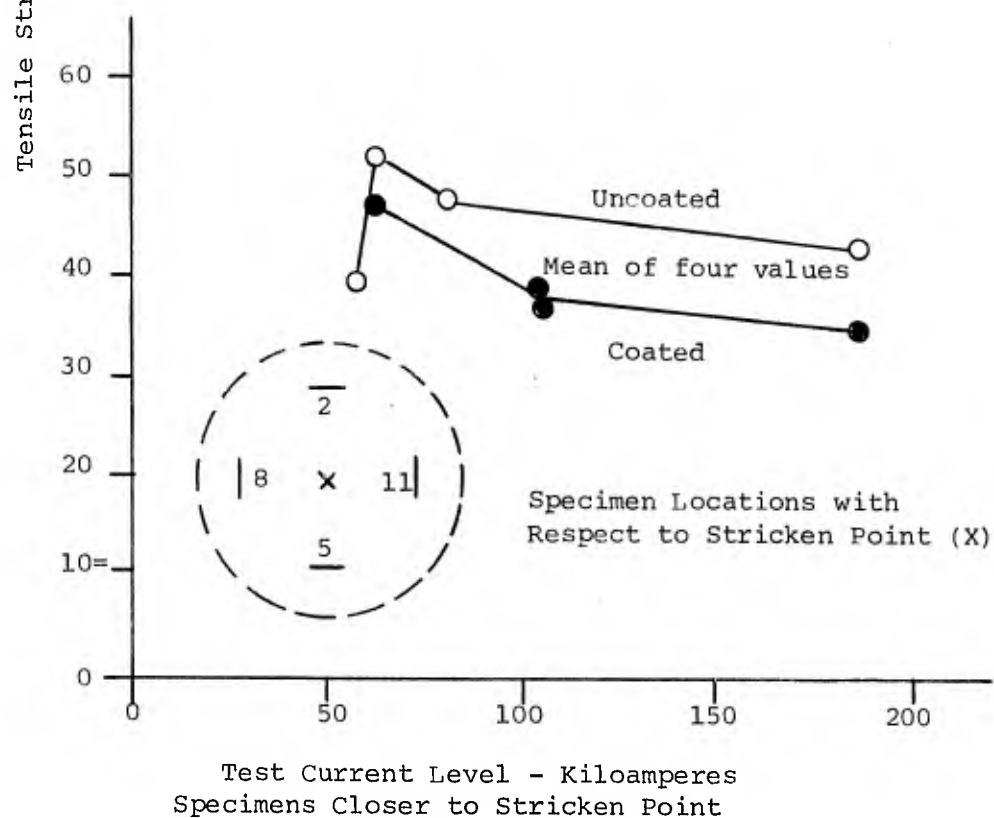
The samples for tensile strength measurements were cut in a pattern that allows one to compare the strength of the panel at different distances from the stricken point. Figures 77 and 78 show the tensile strength at various contours around the stricken point. A summary of the more obvious results of the test is as follows:

FIGURE 77 - Tensile Strengths of 0.040" Thick Graphite Fiber/Epoxy Panels at Different Distances from the Stricken Point

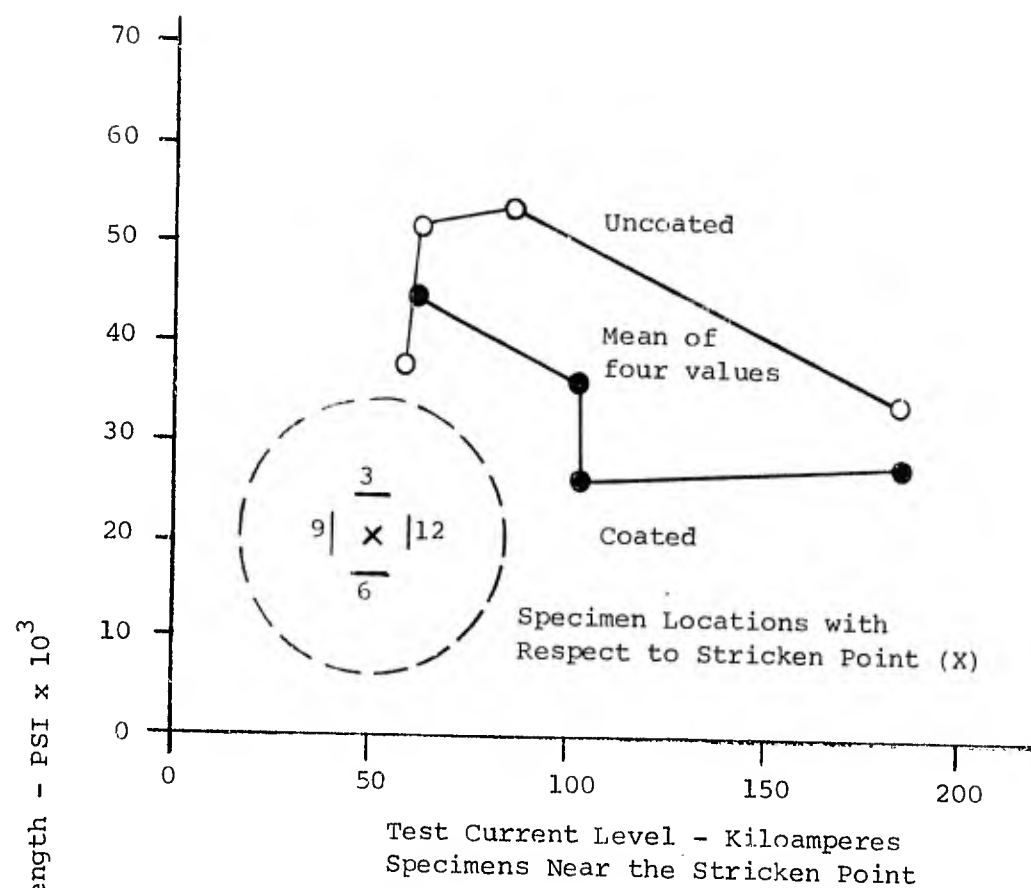
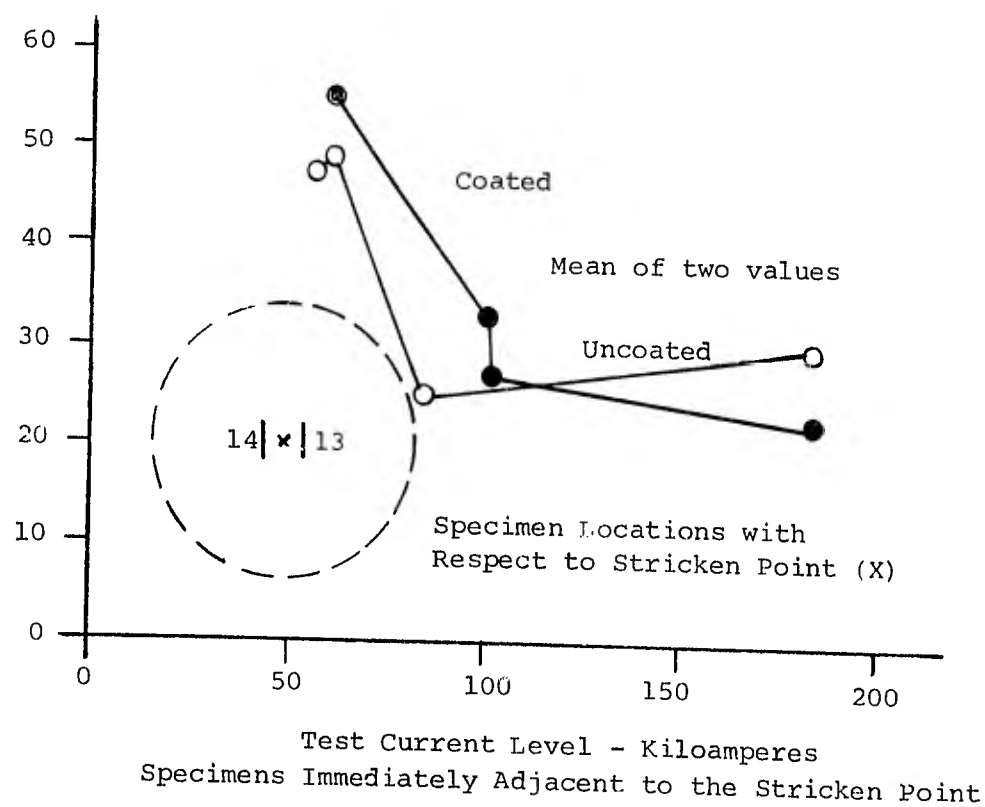
FIGURE 78 - Tensile Strengths of 0.040" Thick Graphite Fiber/Epoxy Panels at Different Distances from the Stricken Point

The samples for tensile strength measurements were cut in a pattern that allows one to compare the strength of the panel at different distances from the stricken point. Figures 77 and 78 show the tensile strength at various contours around the stricken point. No significant difference in mean values was noted at the different locations, at least as regards test current levels around 50 - 75 kA. At the highest test current levels (or immediately adjacent to the stricken point) the mean tensile strengths were low, but visual observation of the surface of the panel at those points would indicate that the strength should be low. The fact that the specimens from the panels "protected" with silver paint were lower than those from the unprotected panels should not be overlooked.

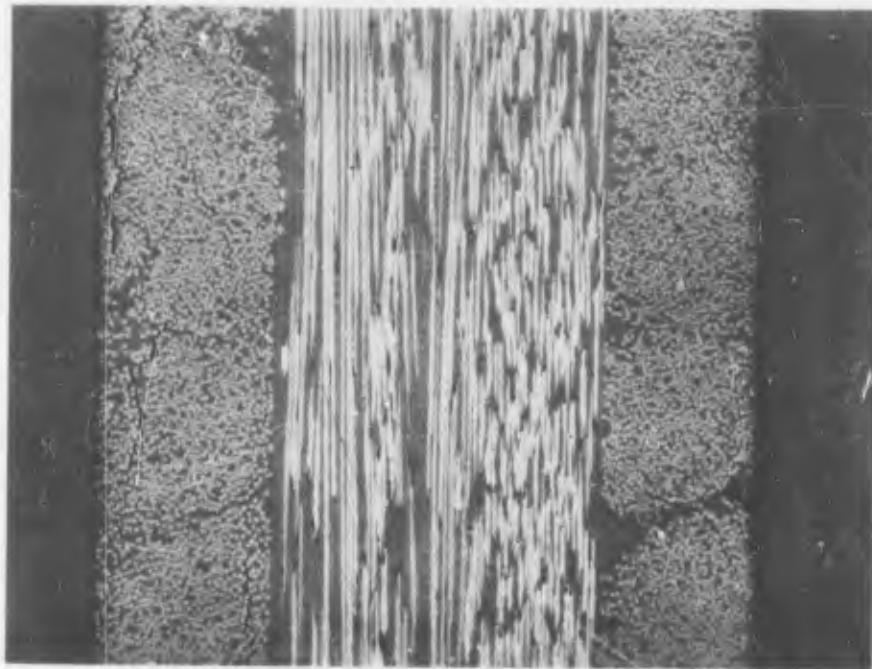
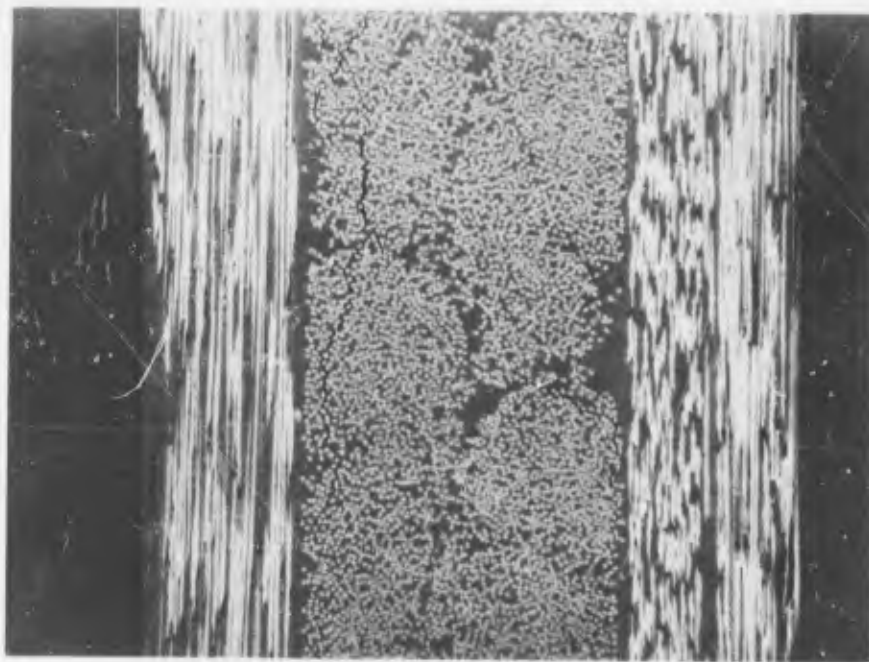
All photomicrograph designations correspond to the tensile specimen numbers listed in Table XIV. Thus, Figure 79 represents the appearance of the fibers perpendicular to and parallel to the outer plies in the immediate vicinity of tensile specimen no. 1.

Most of the damage observable on these photomicrographs appeared to be mechanical in nature, and not due to thermal degradation of the fibers. Particularly as regards panel LS-70-3, the characteristic damage observed consisted of a series of cracks running parallel to the individual fibers. Some cracks were noted on the photomicrographs taken before the lightning withstand tests; see Figure 58 for example. None of those cracks were as large as these however. The panels would split easily in a direction parallel to the fiber reinforcements because the only strength of the panel lies in the resin binder. These cracks do not seem to have degraded the tensile strength particularly. Tensile specimens 1 and 2 of panel LS-70-3 both showed average tensile strength, while specimen 3 showed a significantly lowered tensile strength. Specimen 3 had the largest cracks of any of these three, which one might expect, since it was closest to the arc-attachment point. Tensile specimen 8 again showed a lowered strength, but the photomicrographs of it did not reveal cracking any worse than that observed on specimens 1 and 2. Specimens 9 and 14, even closer to the stroke-attachment point, showed reasonably high tensile strengths, even though specimen 14 on the photomicrographs began to show a good amount of physical tearing and lifting of the fibers on the top ply.

FIGURE 79 - 100X Photomicrograph of a Damaged Area of Graphite Fiber/
Epoxy Panel After Exposure to Simulated Lightning Discharge

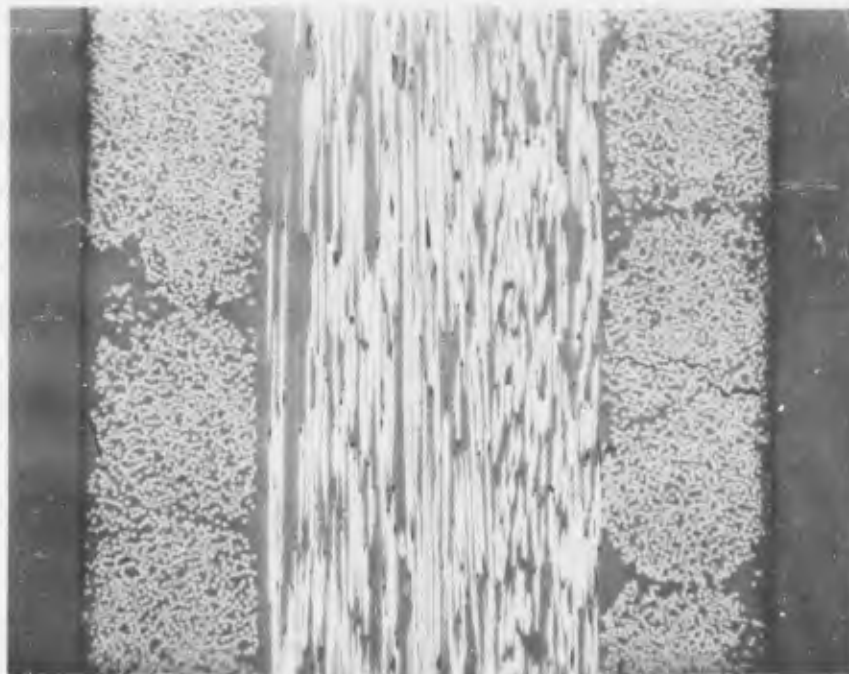
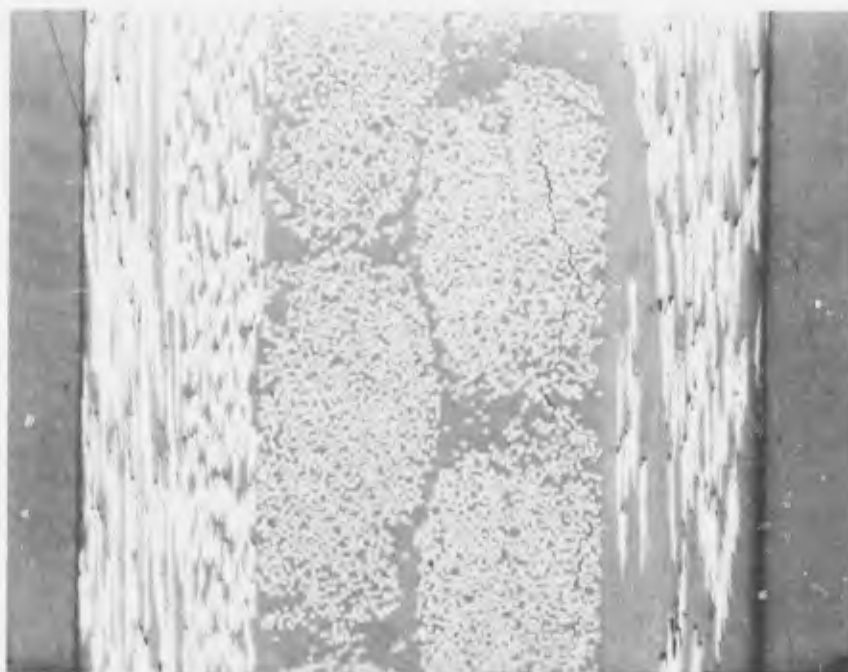
FIGURE 80 - 100X Photomicrograph of a Damaged Area of Graphite Fi
Epoxy Panel After Exposure to Simulated Lightning Dis

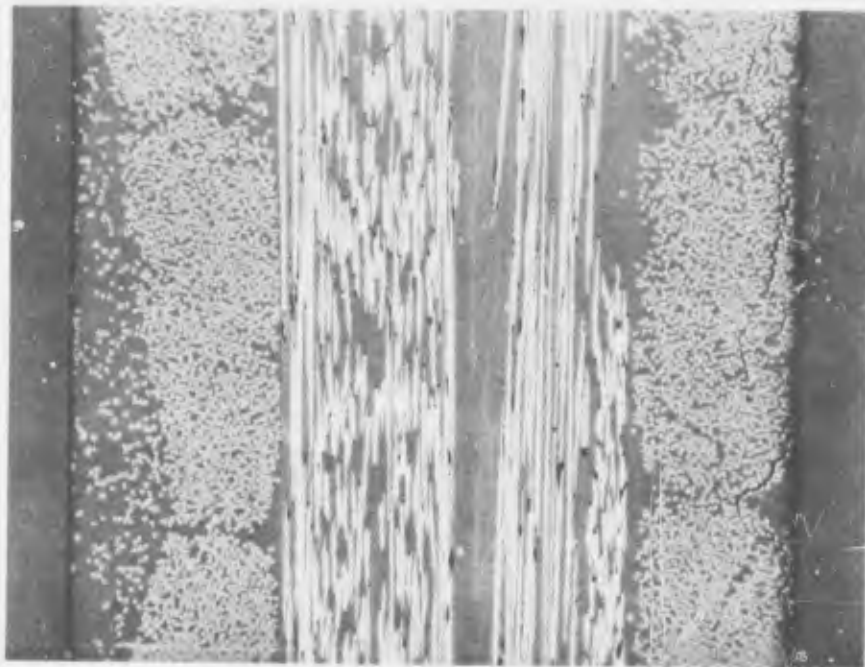
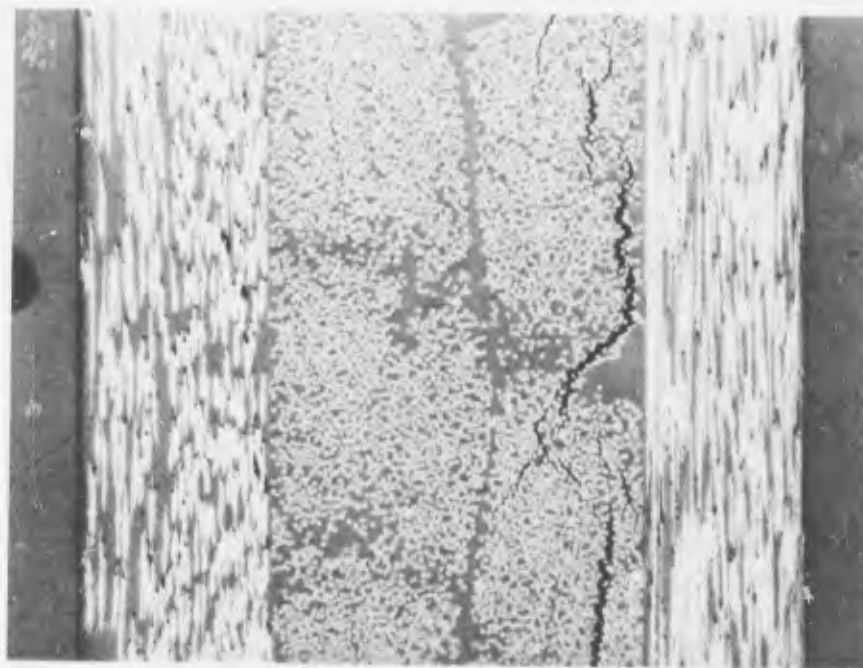
FIGURE 81 - 100X Photomicrograph of a Damaged Area of Graphite Fiber/
Epoxy Panel After Exposure to Simulated Lightning Discharge

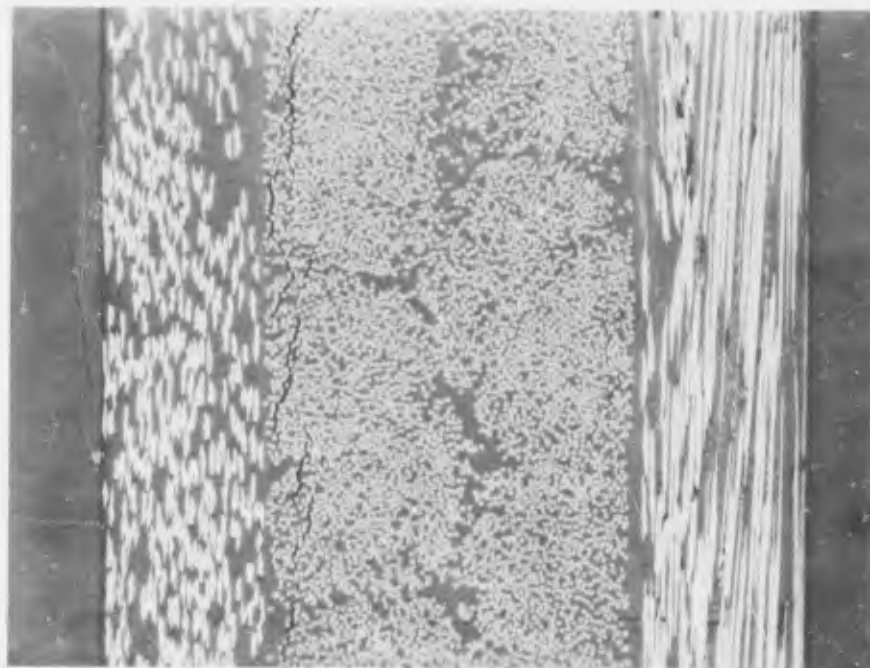
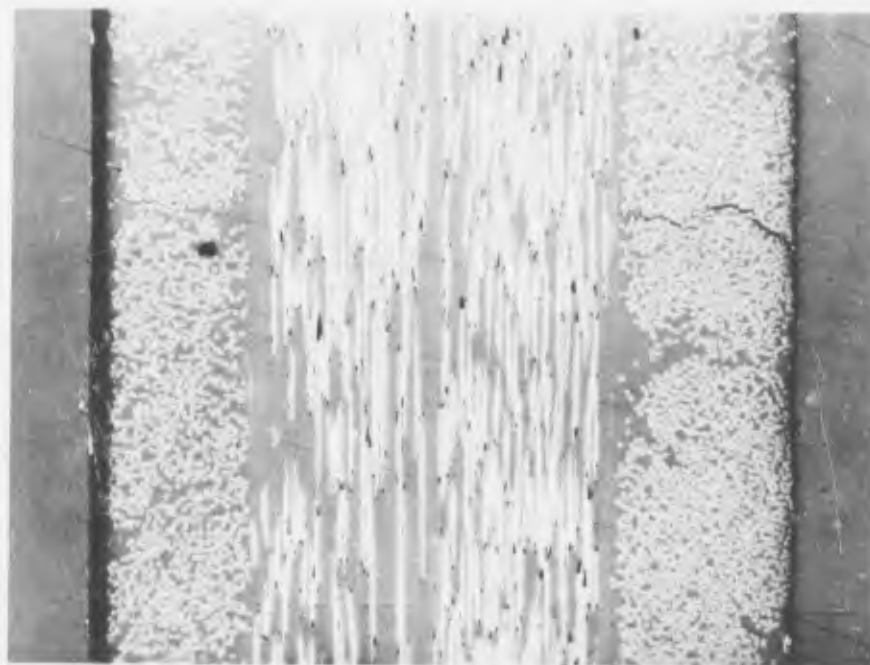
FIGURE 82 - 100X Photomicrograph of a Damaged Area of Graphite Fiber/Epoxy Panel After Exposure to Simulated Lightning Discharge

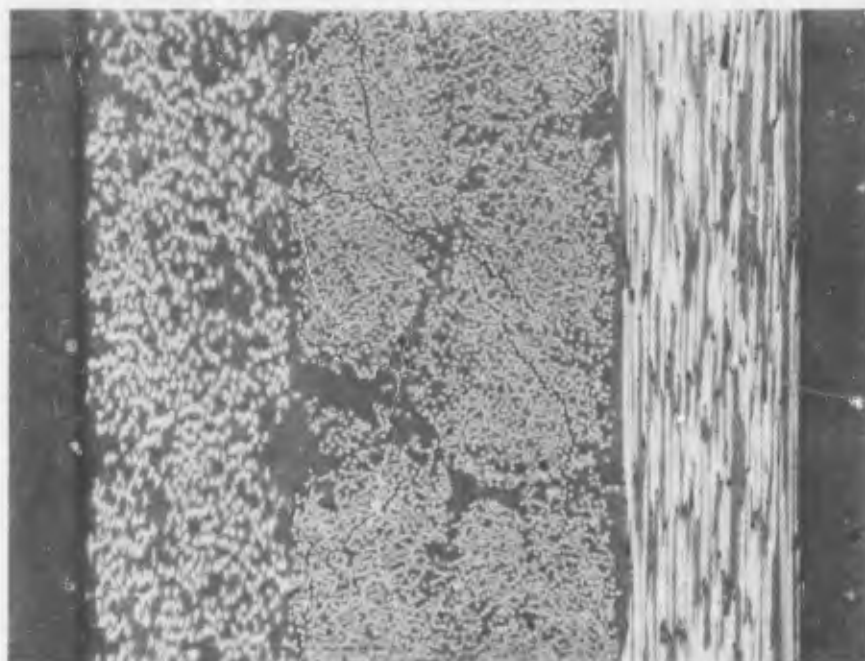
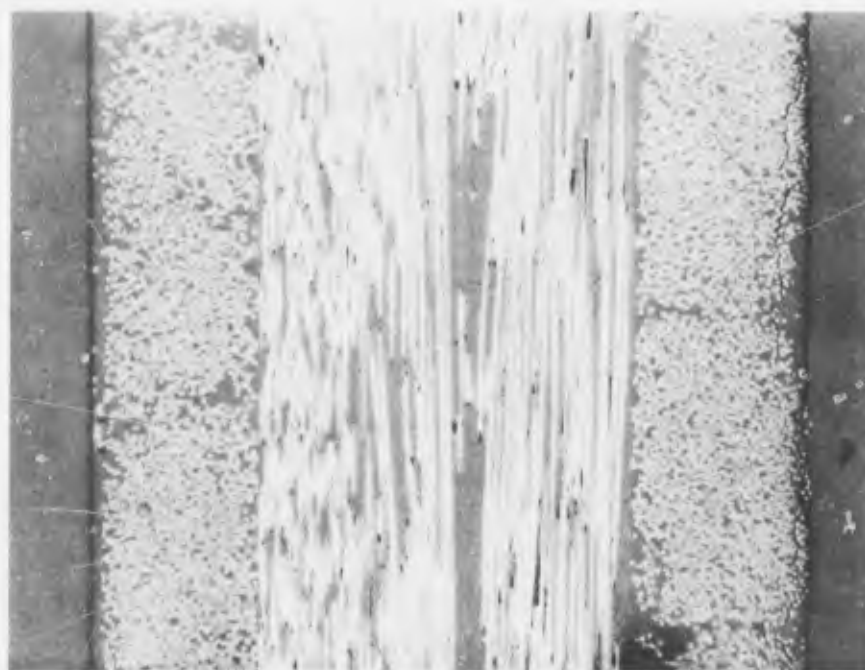
FIGURE 83 - 100X Photomicrograph of a Damaged Area of Graphite Fiber/Epoxy Panel After Exposure to Simulated Lightning Discharge
